# GR-326: STRENGTHENING THE WEAKEST LINK IN MODERN DAY ULTRAFAST OPTICAL NETWORKS

Revision 2

## SENKO ADVANCED COMPONENTS, INC.

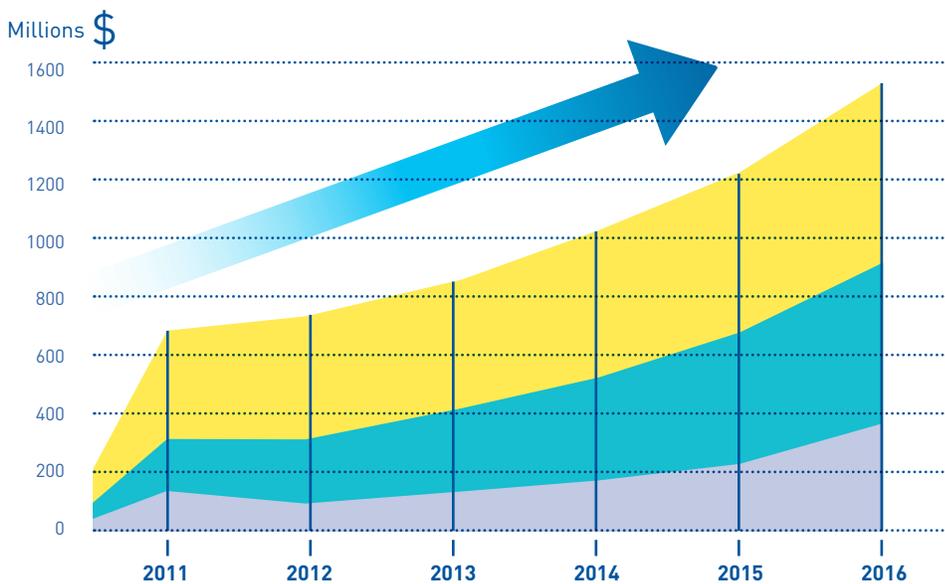
**Figure 1** Increase in Global Demand for Fiber Optic Connectors

In 2012, leading market and technology analysts announced their finding which concluded that in 2016, the worldwide consumption volume of connectors and mechanical splices will increase by a factor of 2, reaching over 1.57 billion units as compared to the number of 703 million in 2011. The American region led in global market share with 54% in 2011. American consumption is forecast to expand to at an average annual growth rate of 10.8% during the forecast period. The Asia Pacific (APAC) region is forecasted to show the fastest growth with an average annual growth rate of 25 percent (2011-2016). EMEA (Europe, Middle East and Africa) fiber optic connector volume consumption, with 19.5 percent relative market share, trailed the second-place APAC (Asia Pacific) region in 2011. The forecasted trend is shown in **Figure 1**.

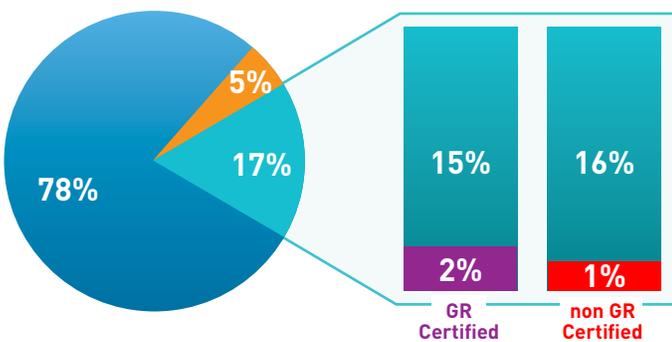
Figure 3

In **Figure 3**, we have compared a 20-year Total Cost of Ownership between the uses of GR-326CORE versus non-GR-326CORE connectors. The analysis clearly shows that although initial CAPEX is less for non-GR326CORE case but in the span of 20 years, the average cost (repair of faulty connectors and loss of revenue) will be 2x the cost of using a GR-326CORE certified connector. The additional 1% per home pass for using a GR-326CORE certified connector is definitely a worthwhile assurance by any experienced network operator.

### Cost analysis of GR-326CORE vs non-GR-326CORE connectors

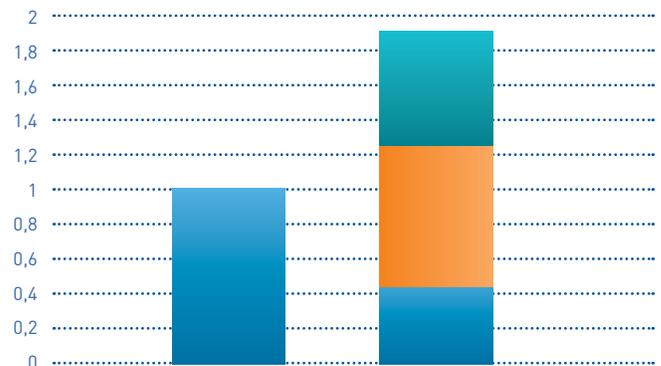
Figure 4

### Total Cost of Ownership Comparison between GR-326CORE vs non-GR-326CORE Connectors

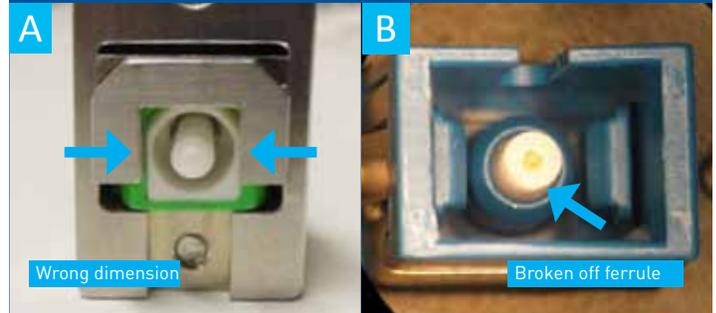
Connector dimensional non-compliance can result in engagement and disengagement force issues, but just as seriously, they **may not fit into industry standard test equipment**. Figure 5A shows an SC APC connector unable to fit into a Data-Pixel interferometer chuck, due to an inner housing that is wider than that specified by international standards. Figure 5B shows a ferrule lodge into the adapter and unable to be removed as the dimension of the adapter was too small. Eventually, the ferrule broke off from the connector body.

**Figure 5:** Non-compliant to standard dimension could cause  
A) Fitting mismatch or even B) Damage during operations

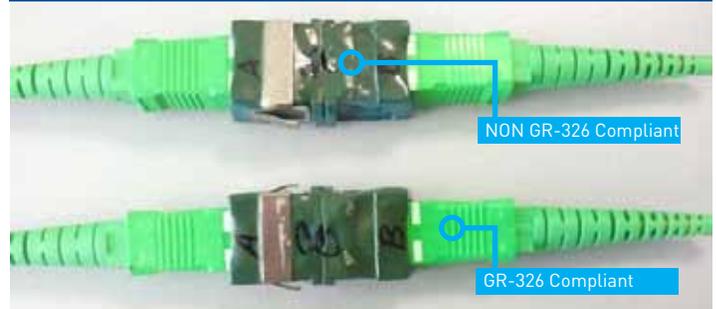
Use of substandard materials can result in discoloration, distortion and mechanical malfunction when put through environmental testing. Discoloration as shown in Figure 6A is not of great concern, but distortion and mechanical failure is as seen in Figure 6B. Figure 7 shows the worst case scenario of SC adapters melting during damp heat testing. Note that in the same photograph, the GR-326 compliant connectors attached to the adapter were not affected by the testing and retained its integrity.

**Figure 7:** Sub-standard Material unable to withstand environmental test

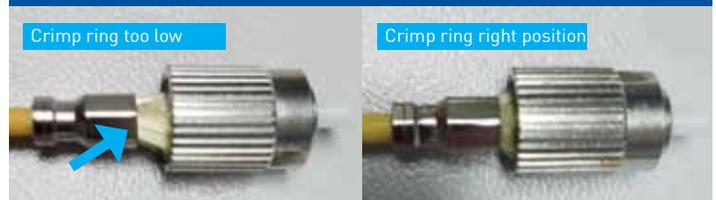
Due to improper crimp ring placement during crimping, the upper most FC connector in Figure 8 exhibited cable retention pull force well below the requirements specified GR-326. More seriously shown in Figure 9A & 9B, where there is a gap between the ferrule and the flange during the termination process. If the gap is too big, that place becomes an air pocket which will, during expansion at higher temperature, exert pressure on the fiber thus causing the fiber to break (Figure 9C). A sample of a good connector can be seen in Figure 9D.

**Figure 8:** Improper crimp ring placement during crimping

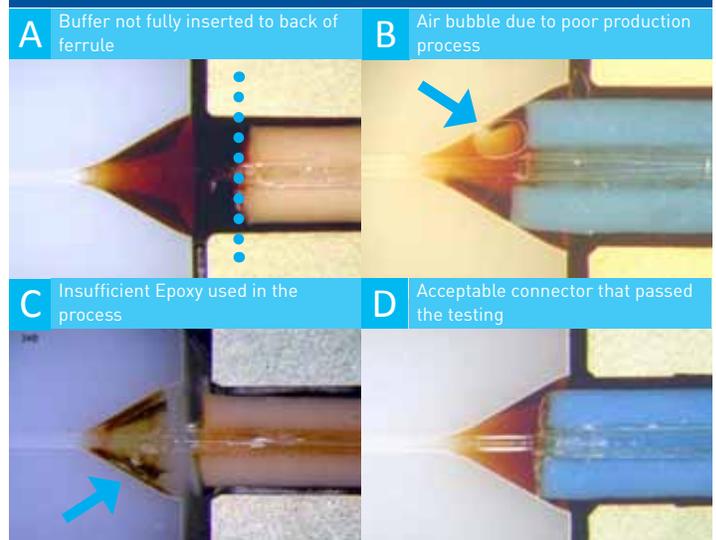
**Figure 9:** Samples of connector terminations quality
